Manhole Inspection Summary

Manhole # S43UU_033MH

Insp Date: **2/12/07 1:59 PM**

Location Address: **1512 ABBOTTSTON ST**

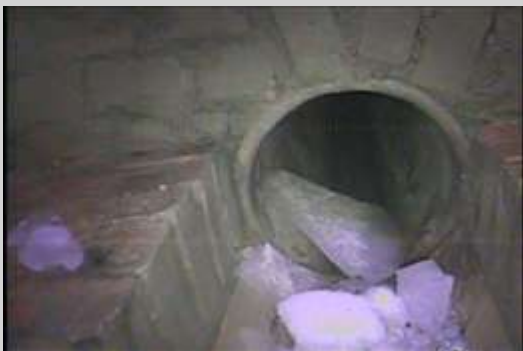
8 in. Circular Gravity Sewer Pipe In @ 6 O'Clock

Rod and Bar (Angled)

Pipe Material: **Clay** ☐ Pipe Lined

Invert Depth: **7.51** (ft.) Flow Characteristics: **Slow**

Deposits: ☒ None ☐ Mud ☐ Sludge ☐ Debris ☐ Grease

Infiltration: **None** Pipe Seal Cond: **Unknown**

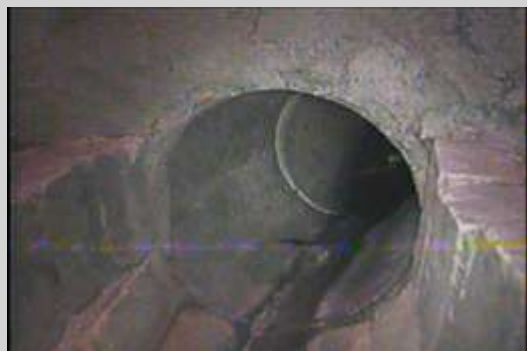
8 in. Circular Gravity Sewer

Rod and Bar (Angled)

Pipe Material: **Clay**

Infiltration: **None**
